MODEL
XJ, S-TYPE,
X-TYPE

NUMBER
S527
Revision 3

TECHNICAL BULLETIN

SERVICE ACTION: Key Fob Modification

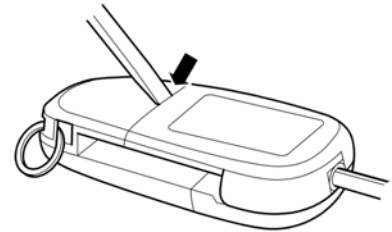
Figure 1

1. Remove the back section of the remote control key fobs using a suitable thin screwdriver. (Figure 1)
2. Check for the part number '1X43 15K601 AJ' located on the key fobs. (Figure 2)
3. If the part number is **1X43 15K601 AJ**, no further action is necessary, re-assemble the key fob.
4. If the part number is **NOT 1X43 15K601 AJ**, perform the "Install Insulating Foam Pad" section below on affected fobs.

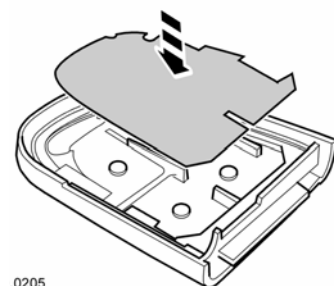
Figure 5

CAUTION: Failure to locate the foam pad correctly can result in loss of functionality of the remote control key fob.

1. Install the foam pad in each remote to be updated as follows:
 - Open the remote control key fob using a suitable thin screwdriver. (Figure 3)
 - Place the open halves of the remote control key fob on a clean dry surface. (Figure 4)
 - Insert the new foam pad into the remote control key fob where the buttons are situated. (Figure 5)
