Driveline Whine –  
Preliminary Checks

MODEL 2002-04 MY  
X-TYPE

VIN C00294-E02938

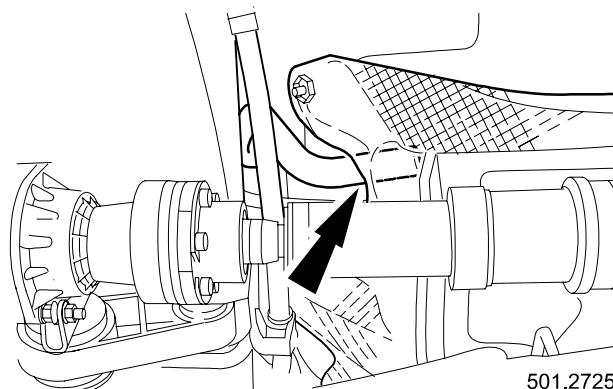
ILLUSTRATION 1

**ROUTING OF A/C DRAIN HOSE**

1. Raise vehicle on a lift.
2. Check the air conditioning (A/C) drain hose for correct routing (Illustration 1).
