Exterior Door Handle –
Noisy When Released –
Install New Rubber Buffers

MODEL 2002 MY-ON
X-TYPE

VIN C00001-ON

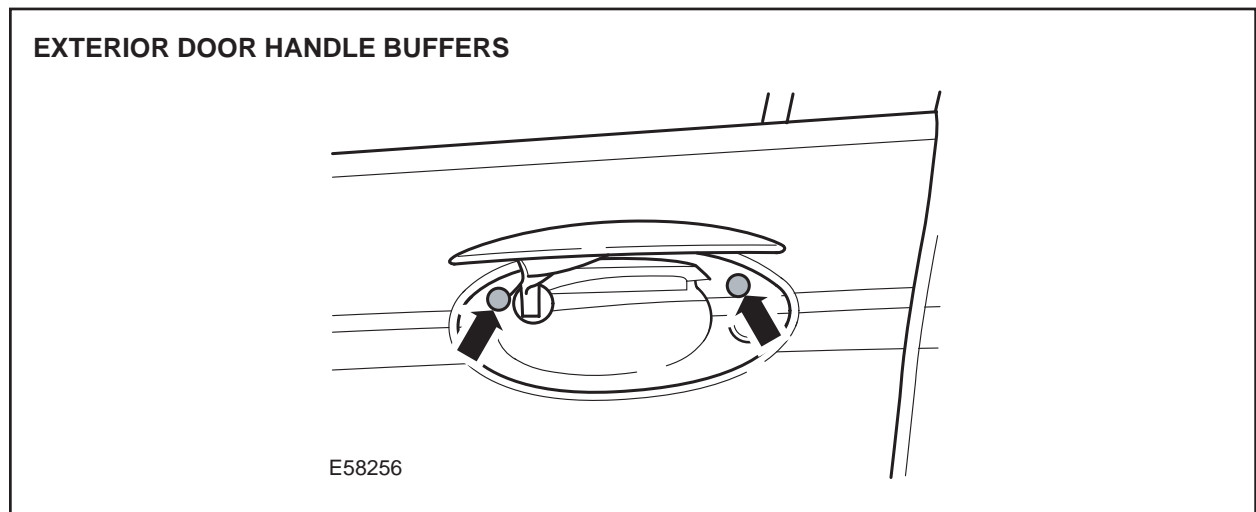
ILLUSTRATION 1

On some X-TYPE vehicles, customers may have a concern of noise from the exterior door handle when released. This can be caused by missing or displaced exterior door handle rubber buffers.

1. Lift the exterior door handle 'up' and hold in the highest position.
2. Apply a suitable grease to the new rubber buffers (to aid installation).
3. Install the new rubber buffers to the exterior door handle.

4. Release the exterior door handle.
5. If required, carry out steps 1 to 4 for the remaining exterior door handles.
