Technical Bulletin No: XT303-181
Issue Date: Dec 04
Vehicle: X-Type 2002 MY-ON
VIN: C00001-ON

Engine Oil Leak Misdiagnosis - Vehicles With Automatic Transmission

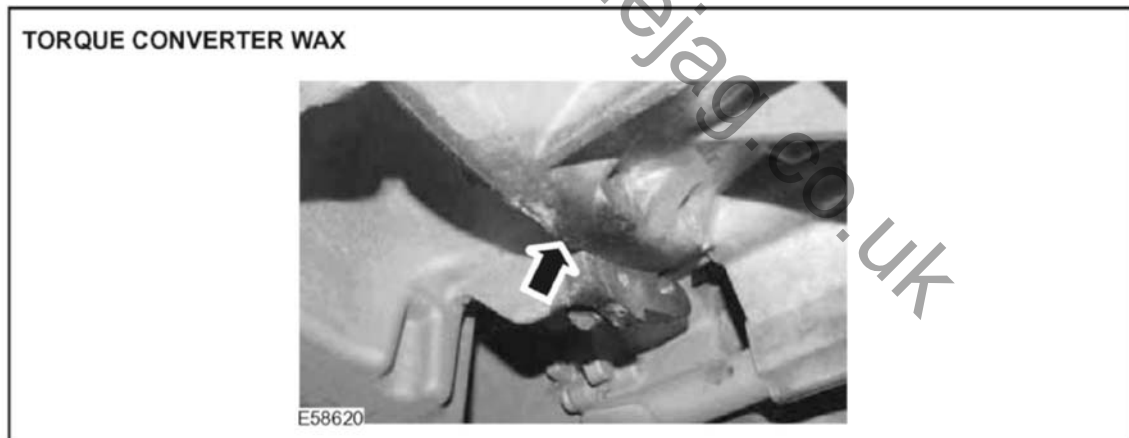
ILLUSTRATION 1

On some 2002 MY-ON X-TYPE vehicles, the torque converter protection wax can soften and run on to the torque converter housing giving the appearance of an engine oil leak.

Using a suitable cleaner, clean the wax/oil from the torque converter housing/sump area, then road test the vehicle, and recheck for the oil leak.

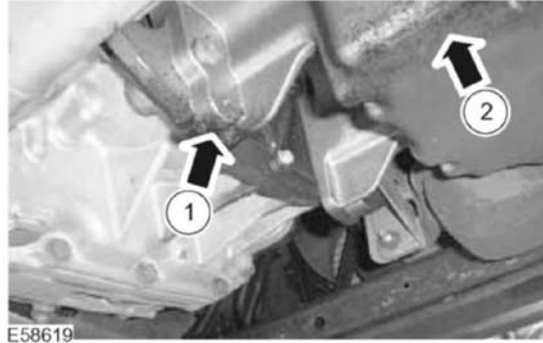
ILLUSTRATION 2

Refer to Illustration 2 for the difference in appearance between a torque converter wax (1) and a sump seal leak (2) collecting in the same location.

TORQUE CONVERTER WAX AND OIL SUMP SEAL LEAK
